Village of Arlington Heights, Municipal Campus – Police Station

Physical Building Analysis Summary from 2010 Analysis

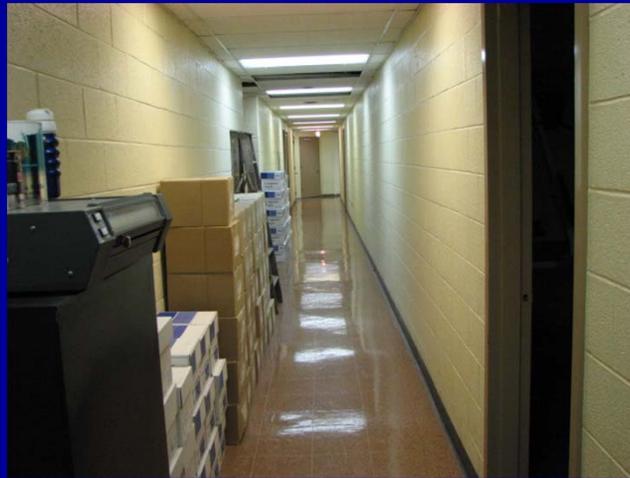
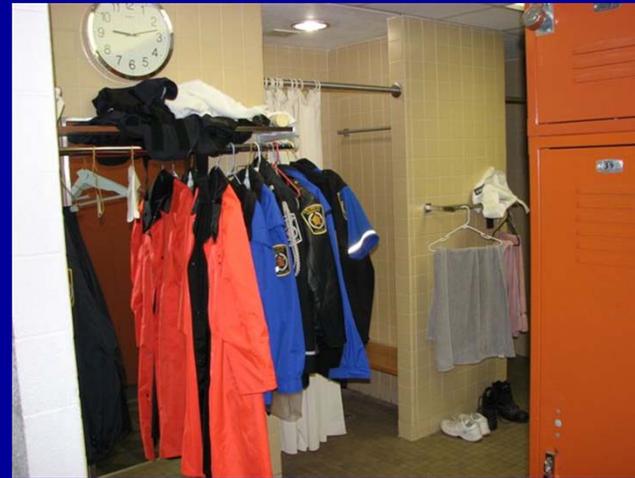
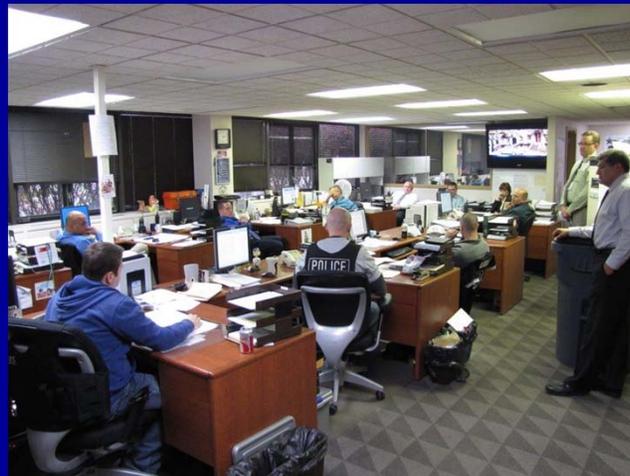
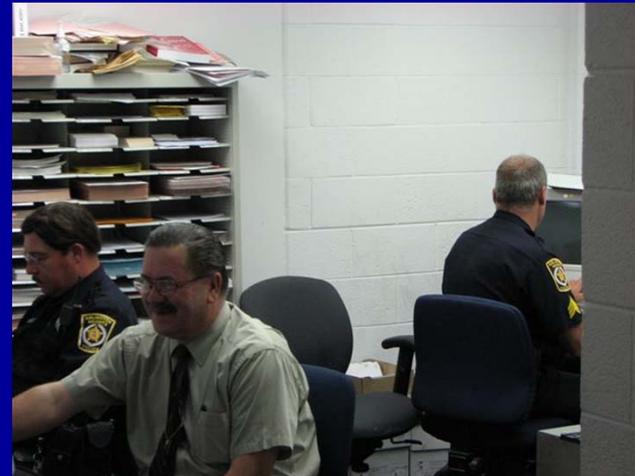
Significant Lack of Space - 38,000 sq. ft.

- Capacity is beyond maximum.
- When built Police Department was 80. Current Department 139 employees.
- Similar Police Departments substantially larger e.g. Palatine 70,000 sq. ft. Hoffman Estates 79,000 sq. ft.

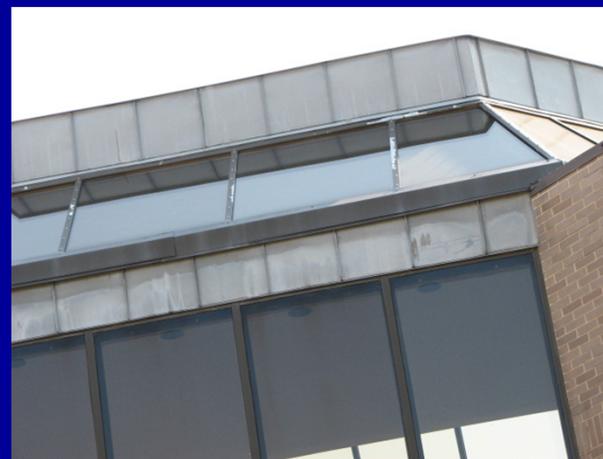
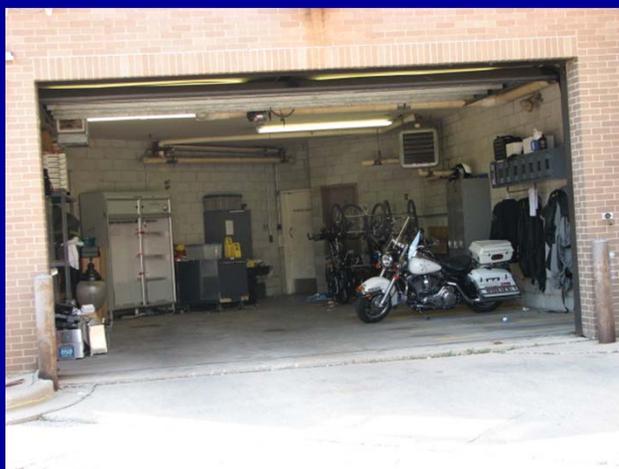
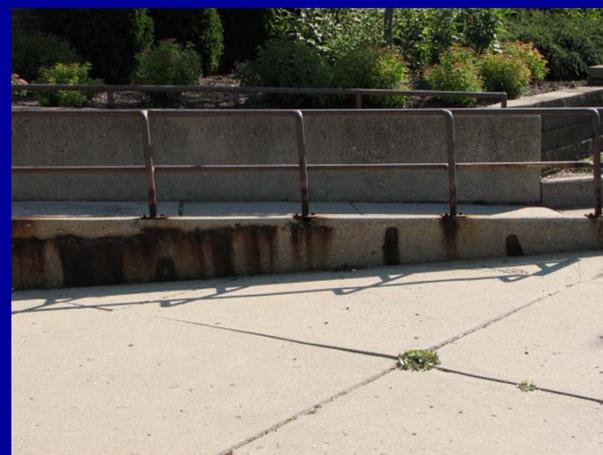
Architectural / Building

- Roof and windows are beyond their useful lives.
- Facility is not handicap accessible.
- Facility is not compliant with current code.
- Building finishes are marginal to deficient.
- Range is not up to current standards.
- Public vs. private areas are not secured.
- Divisions are not contiguous and Division adjacencies are marginal.
- Sally port safety is questionable.
- Capacity of facility is at a maximum.
- Low floor to floor heights limit new state of the art systems.

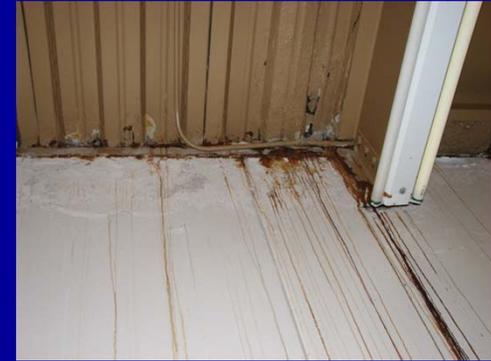
Structural

- Facility is not an essential structure per code.
- Garage is not an essential structure per code.
- Condition of certain floor slabs and foundation walls is marginal.
- Facility will not accept vertical expansion.

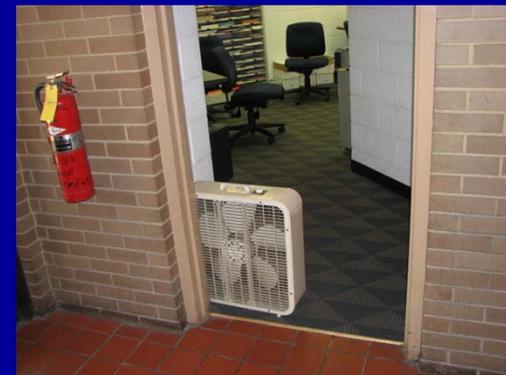
Mechanical

- HVAC systems and controls are beyond their useful lives.
- HVAC systems have no extra capacity.
- There is no smoke evacuation system in the atrium.

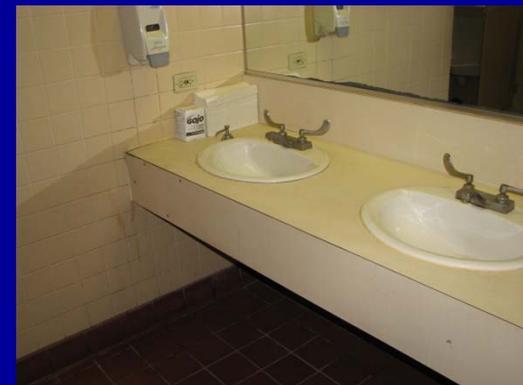
- Plumbing systems have no extra capacity and lack backflow preventers.

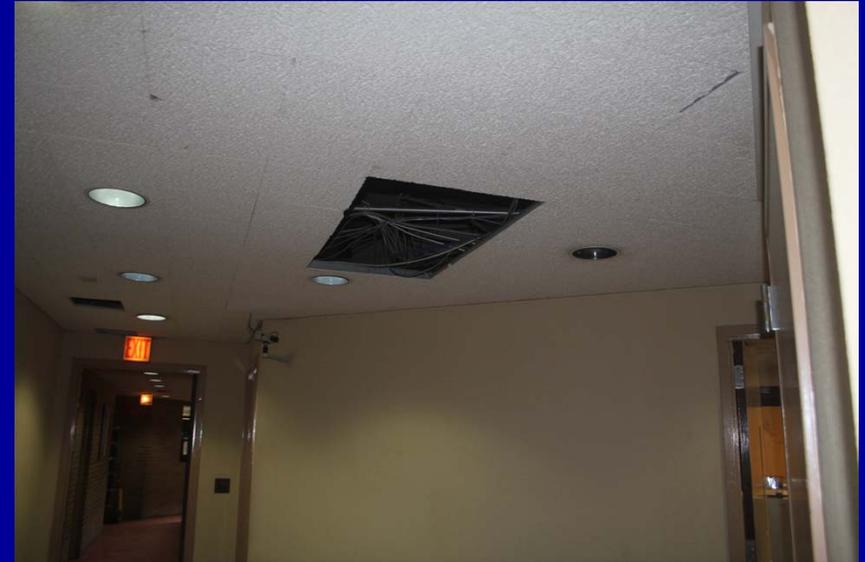
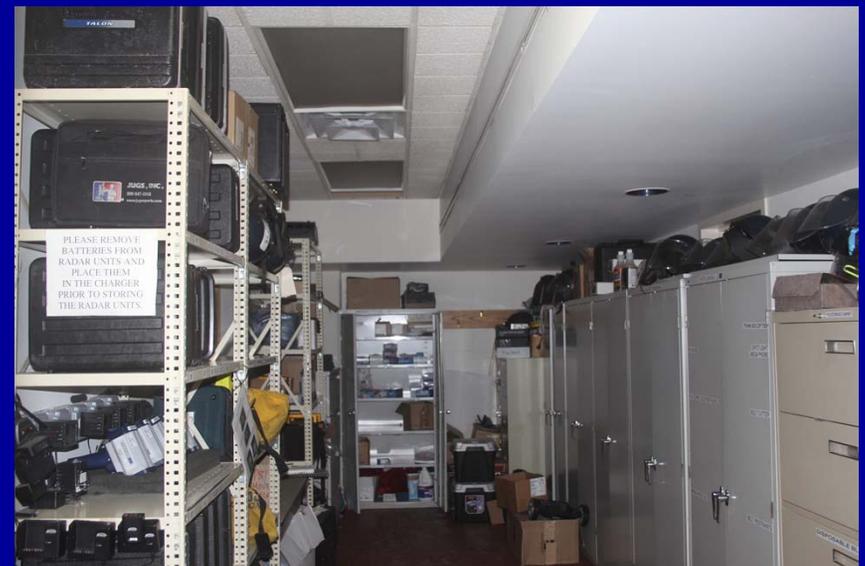
- Sprinklers are at a minimum in the facility.

- Electrical capacity is at a maximum.
- Electrical service is deficient.
- Systems do not meet current code.
- Condition of equipment is beyond its useful life.
- Lack of adequate outlets and energy efficient lighting.

- Lacks visual notification.
- System is not serviceable.
- Capacity, number of devices and smoke detection is marginal.

- Well beyond its useful life.
- Installed with original building.
- Removal & replacement challenging & costly.

- Severe lack of storage.

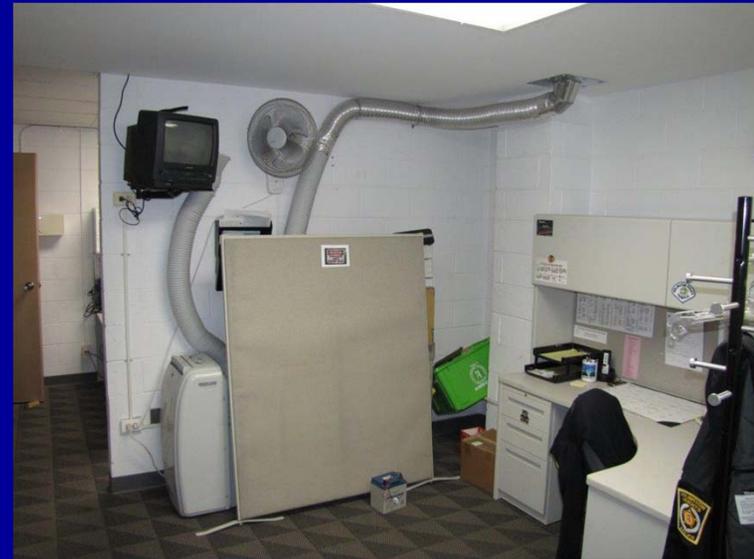
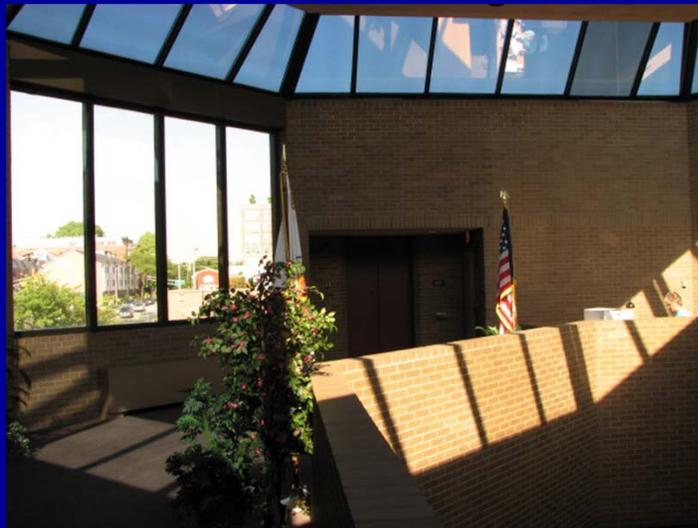
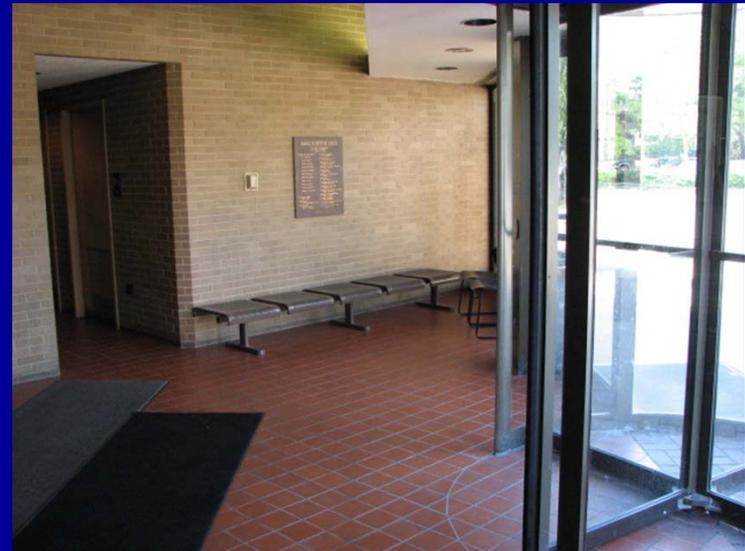
- Technology installation and distribution is deficient.

- Inadequate speakers throughout.

- Deficient throughout.
